INDOOR AIR QUALITY ASSESSMENT

**Worcester Fire Department, Engine 15
86 McKeon Road
Worcester, Massachusetts**

Prepared by:
Massachusetts Department of Public Health
Bureau of Environmental Health Assessment
Emergency Response/Indoor Air Quality Program
December 2003

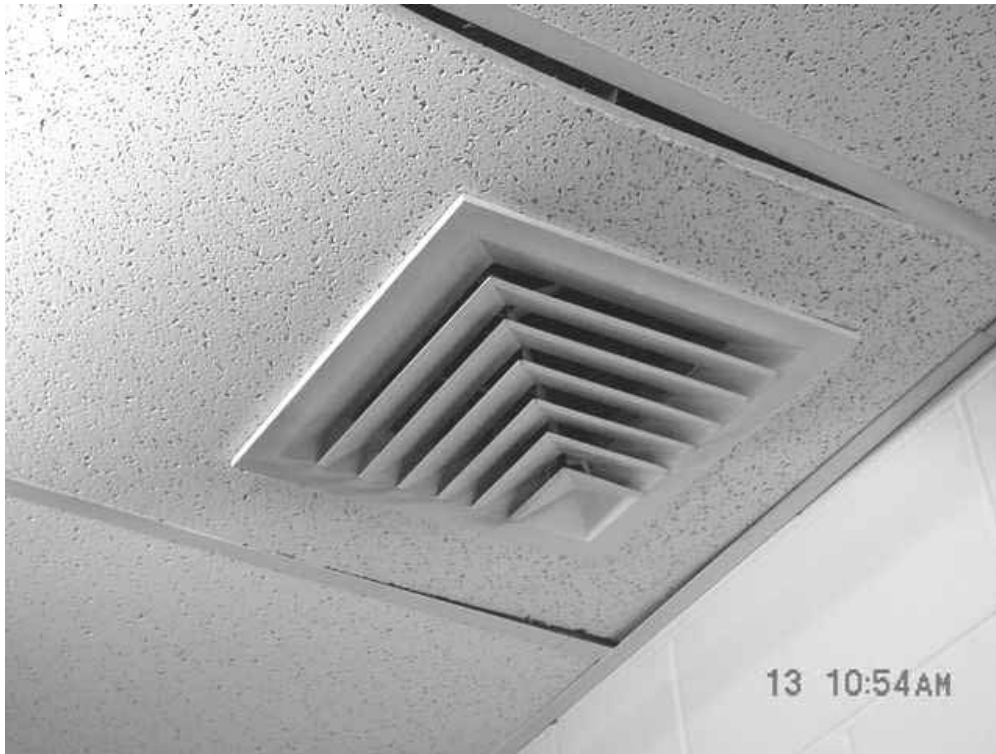
Picture 1

Ceiling-Mounted Supply Vent

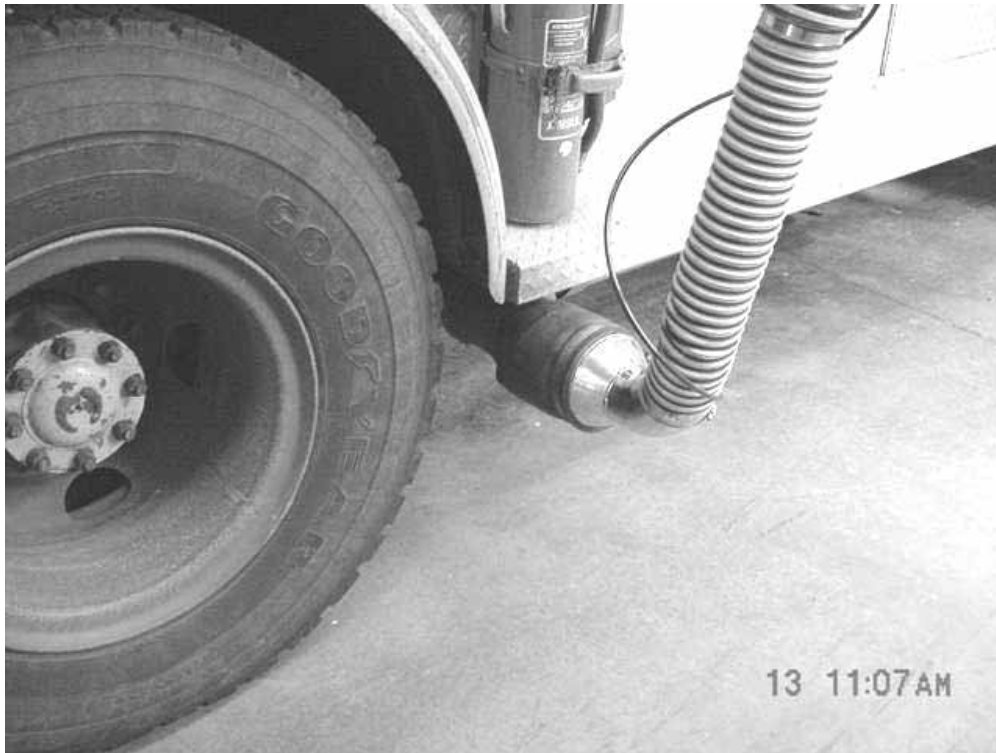
Picture 9

As mentioned previously, the station is equipped with a mechanical exhaust system to remove exhaust from the engine bay during vehicle idling. The system in use at the station connects directly to the tail pipe of the engine via a pressurized cuff (Picture 9). As the vehicle exits the station, the cuff, which is pulled on a runner, trips a trigger releasing the cuff. The system is designed to collect vehicle exhaust directly at the source and remove it from the building, minimizing exposure. Although the engine bay is equipped with local exhaust ventilation, a number of pathways for vehicle exhaust and other pollutants to move from the engine bay into occupied areas on both the first and second floors were identified (Figure 1).

Vehicle Exhaust System Attached to Exhaust Pipe
